PARKS, RECREATION, AND COMMUNITY ENHANCEMENT COMMITTEE
A G E N D A

REPORT OF FINDINGS FROM A BUILDING CONDITION SURVEY

Dover Park Recreation Center Building
1210 White Oak Road, Dover, Delaware 19901
Exterior Layout
Location of Observed Exterior Moisture Areas of Concern
May 6, 2013

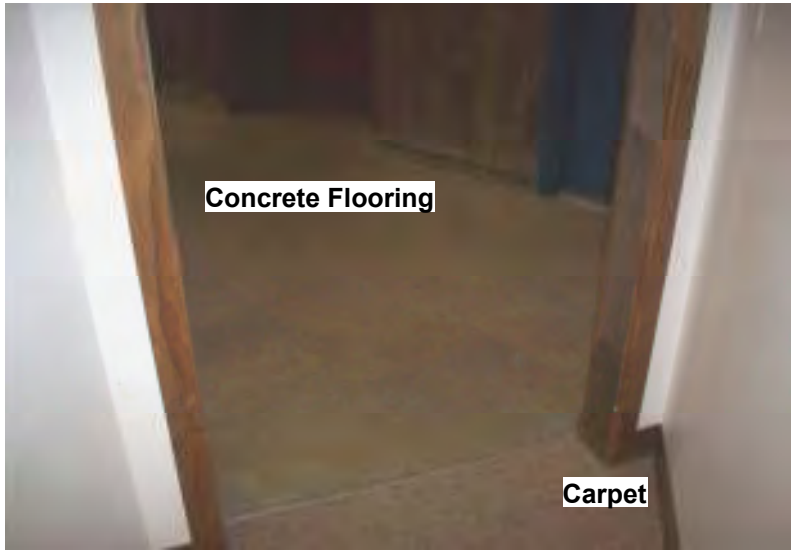
Photograph #5: View drywall and wood ceiling and wall paneling in the Multi Purpose Room.

Photograph #6: View of concrete and carpet flooring inside the building.

Photograph #8: Typical view of fiberglass insulation located above a drop ceiling. Red arrow points to fiberglass insulation.

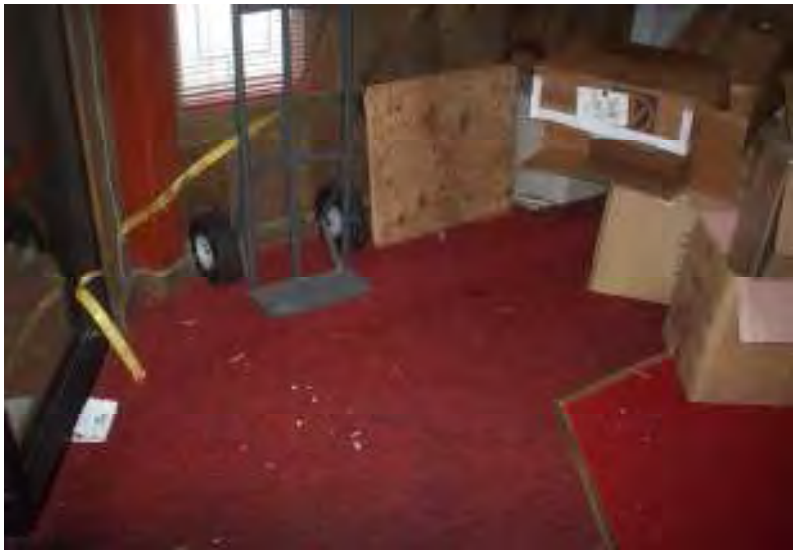
B. Carpet flooring was observed to be visibly dirt and worn. Please refer to Photographs 9 and 10 as examples.

ii. Interior and exterior wood wall paneling and siding visible along the approximate bottom 1 foot of the walls and around the wall mounted HVAC units and windows predominantly along the east side of the building. However, other areas of water staining on the wood walls were observed in Activity Room No. 2 and Hallway 2 (and closet). Please refer to Photographs 13, 14, 15, 16, and 25 as examples.

Photograph #9: View of carpet flooring located at Office 7.

Photograph #13: View of the water stained wood wall located around the wall mounted HVAC unit in Office 3.

E. Carpets should be evaluated. Carpets should be cleaned or replaced as necessary.

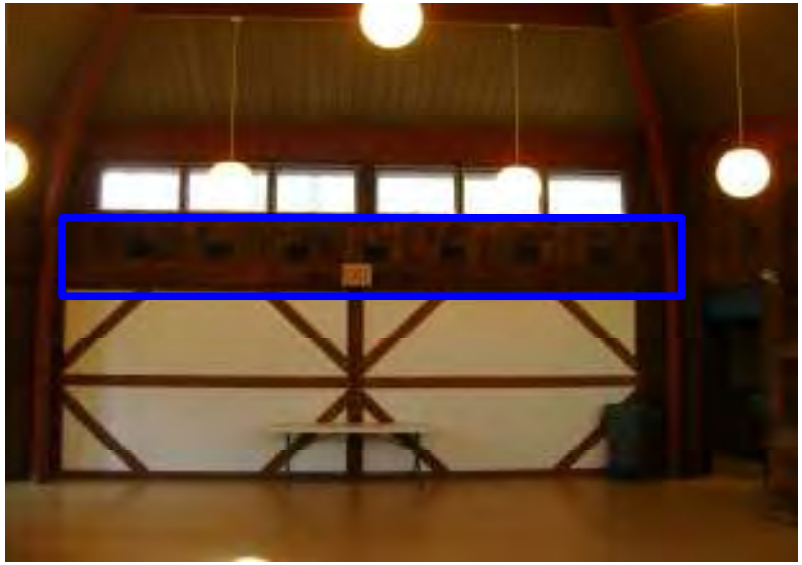
2. Heavy accumulations of apparent settled dust was observed on the wall mounted metal return diffusers and metal ductwork inside the Multi Purpose Room. Additionally, visible accumulations of apparent dirt, debris, and storm water were observed inside the floor air return system located beneath the wood floor in the Multi Purpose Room. Please refer to Photographs 29, 30, 31, and 32.

Photograph #29: View of elevated wall mounted air supply registers located in the Multi Purpose Room. Blue box indicates location of metal supply registers.

A. The HVAC unit and all associated ductwork and piping (supply and return) should be evaluated, cleaned, and repaired as warranted by trained personnel as soon as possible in accordance with the recommendations contained in the National Air Duct Cleaners Association (NADCA). The HVAC system includes but is not limited to air handling units, coils, drip pans, ductwork and piping (supply and return), grilles, registers, diffusers, air filters, and all appurtenances.
