PARKS, RECREATION, AND COMMUNITY ENHANCEMENT COMMITTEE
A G E N D A

PROCEEDING: Parks, Recreation & Community Enhancement
DEPARTMENT OF ORIGIN: Parks and Recreation **DATE SUBMITTED**: July 1, 2013
PREPARED BY: Ann Marie Townshend, AICP/Scott D. Koenig, P.E.
SUBJECT: Future Use of the Dover Park Recreation Center
REFERENCE: N/A
RELATED PROJECT: N/A
REVIEWED BY: Donna Mitchell, CPA, City Controller
EXHIBITS: Report of Findings from a Building Condition Survey, May 6, 2013
EXPENDITURE REQUIRED: $20,000 for Asbestos Removal; $30,000 for Demolition **AMOUNT BUDGETED**: Not budgeted – Bids will have to be approved by City Council **FUNDING SOURCE (Dept./Page in CIP & Budget)**: To be determined by City Manager
TIMETABLE: N/A
RECOMMENDED ACTION: Staff recommends that the Recreation Center building at Dover Park be demolished.

REPORT OF FINDINGS FROM A BUILDING CONDITION SURVEY

Dover Park Recreation Center Building
1210 White Oak Road, Dover, Delaware 19901
Exterior Layout
Location of Observed Exterior Moisture Areas of Concern
May 6, 2013

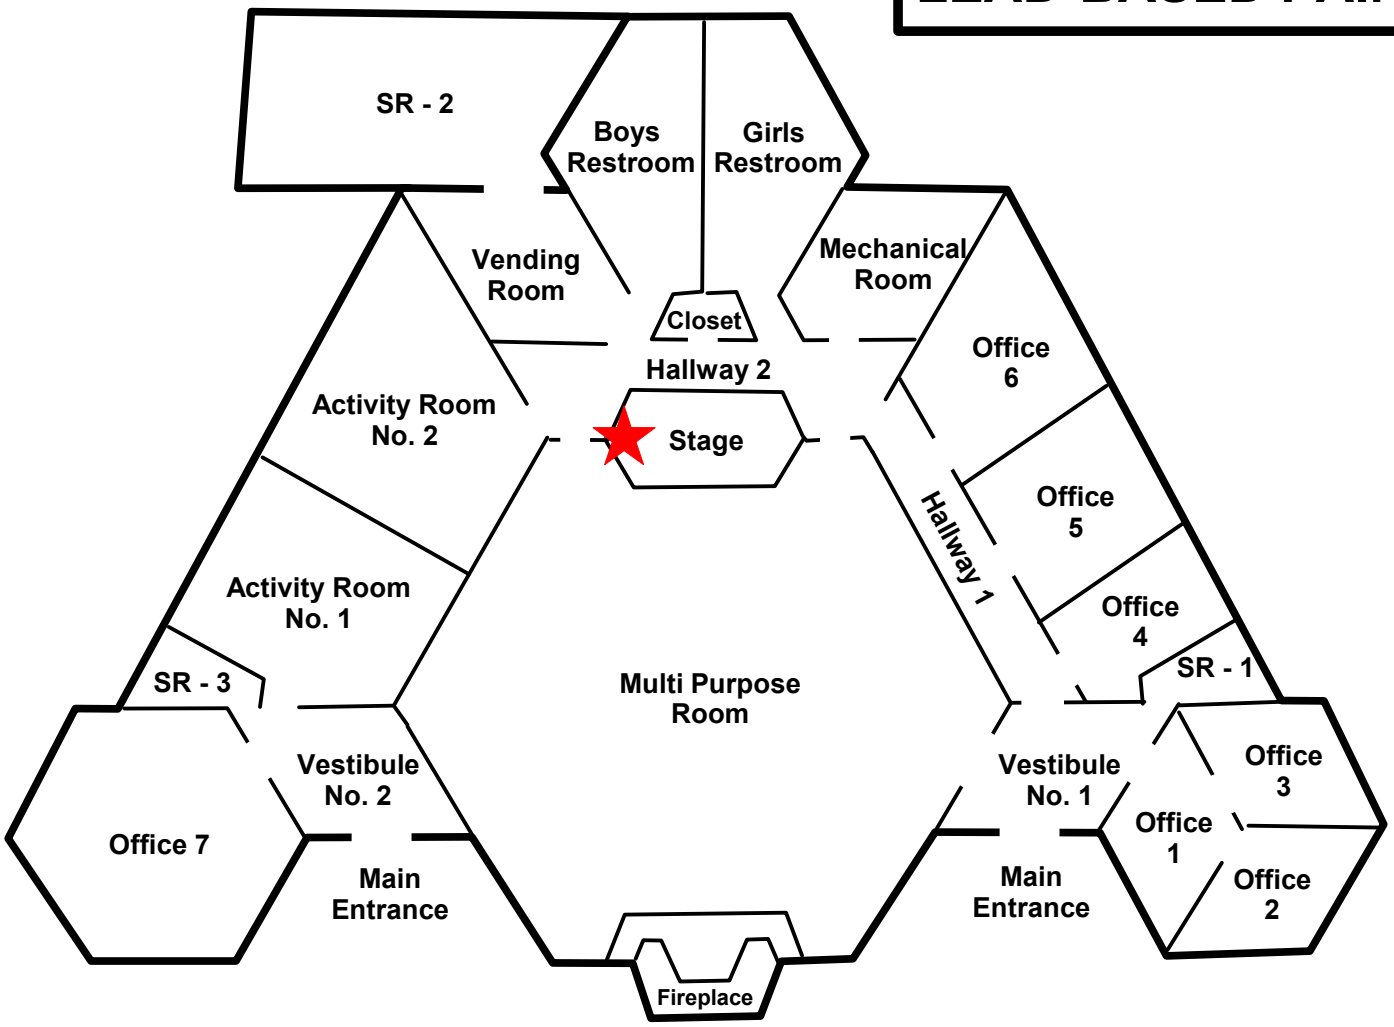
Dover Park Recreation Center Building
1210 White Oak Road, Dover, Delaware 19901
Interior - First Floor
Location of Asbestos-Containing Materials
May 6, 2013

= Joint Compound on Gypsum Board Walls and Ceilings (Approximately 2,800 Square-Feet)

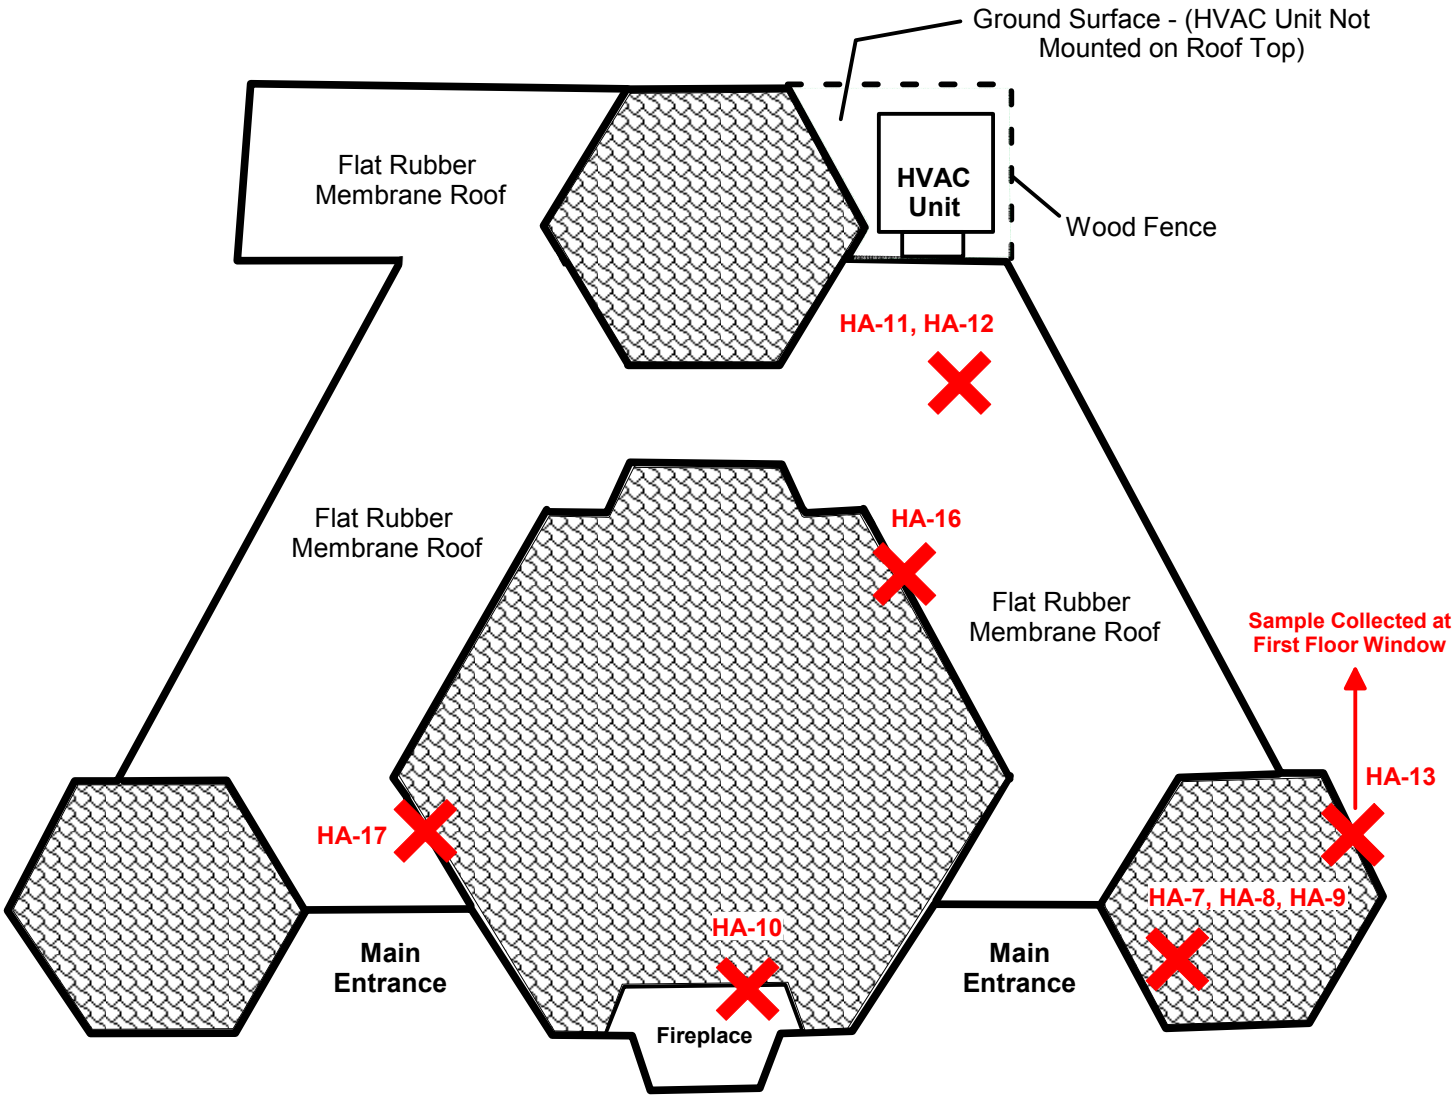
Dover Park Recreation Center Building
1210 White Oak Road, Dover, Delaware 19901
Interior - First Floor
Suspect Asbestos Sample Locations
May 1, 2013

= Location of Suspect Asbestos-Containing Materials Collected on April 16, 2013.
